# Appendix A

## 20 SR SPS Future Flow Technical Memorandum

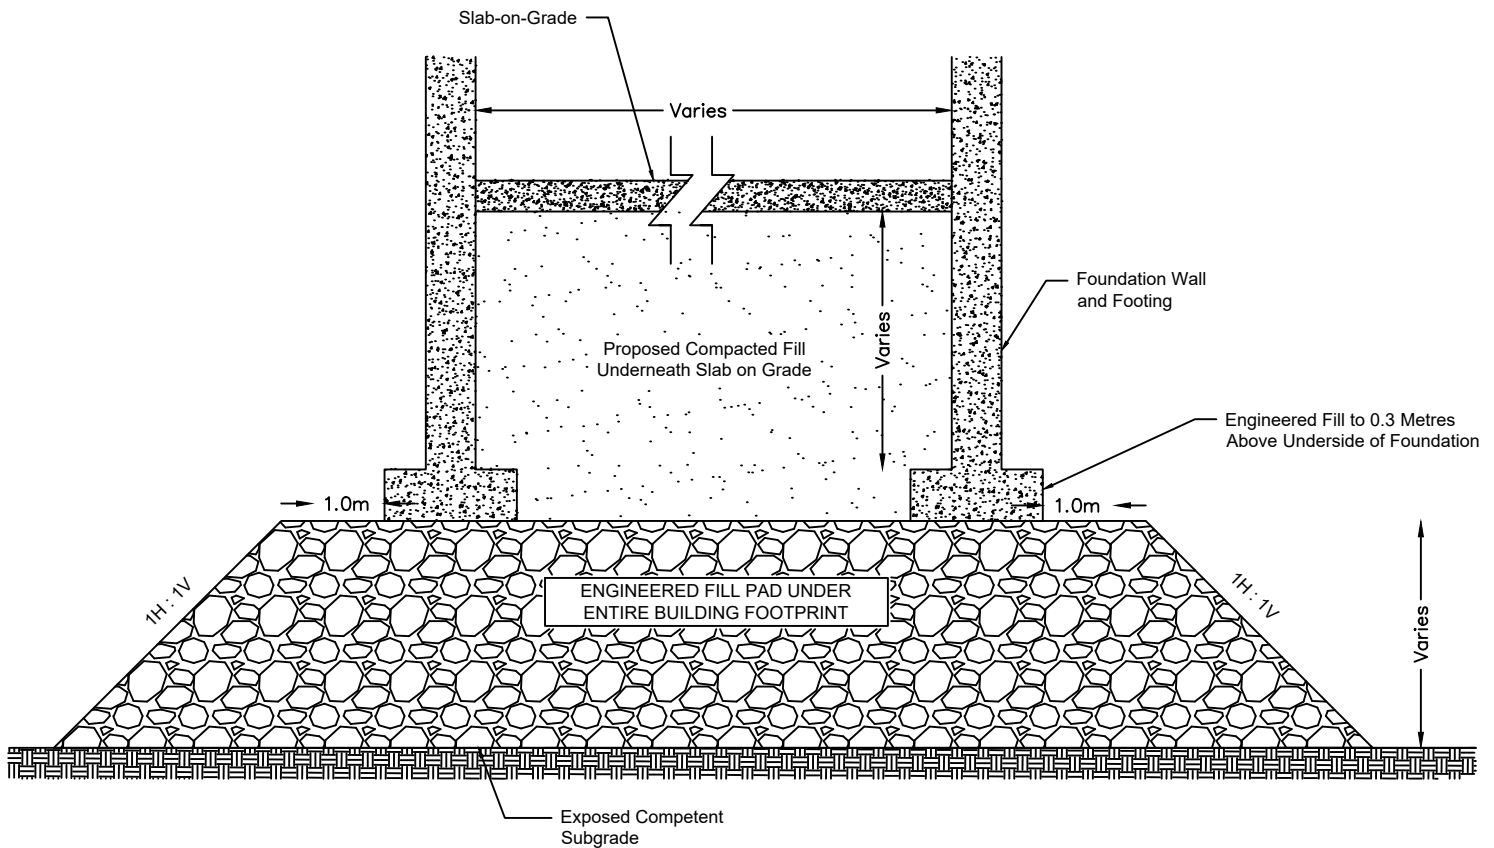
Geotechnical Investigation and Report  
Proposed 20th Sideroad Sewage Pumping Station  
1460 7th Line, Town of Innisfil, Ontario  
February 4, 2025, Proj. No.: 2403367

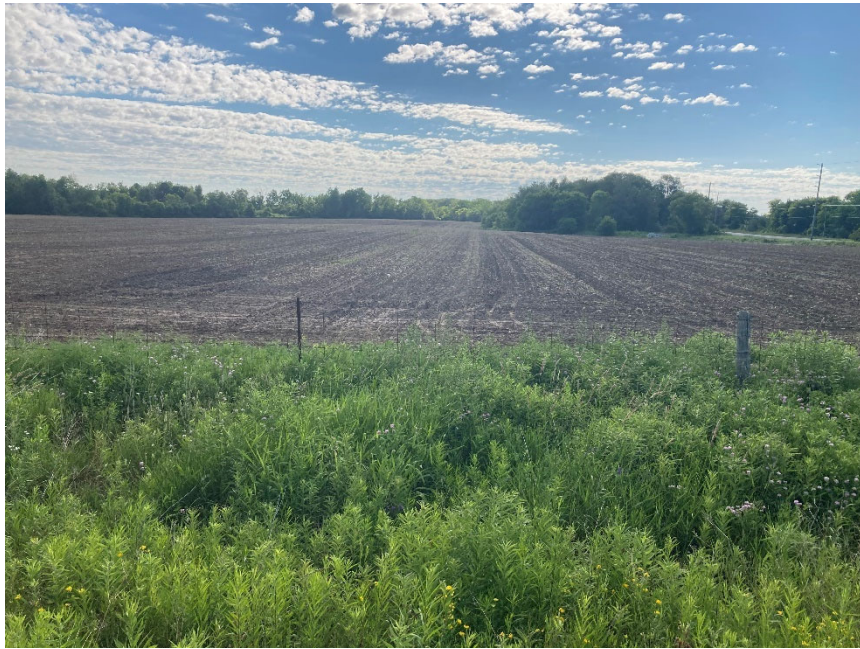
Photograph 1: Location of proposed 20th Sideroad SPS (June 23, 2022)

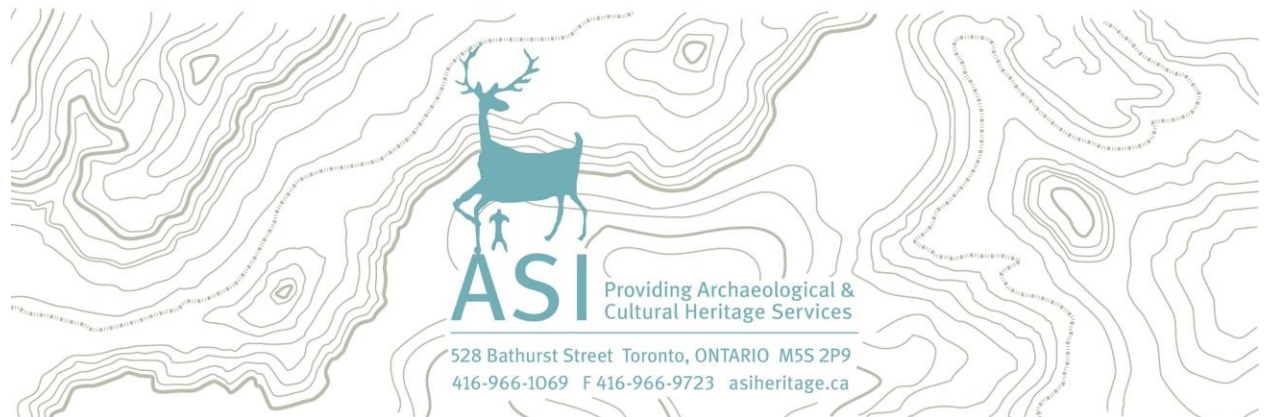
## Executive Summary

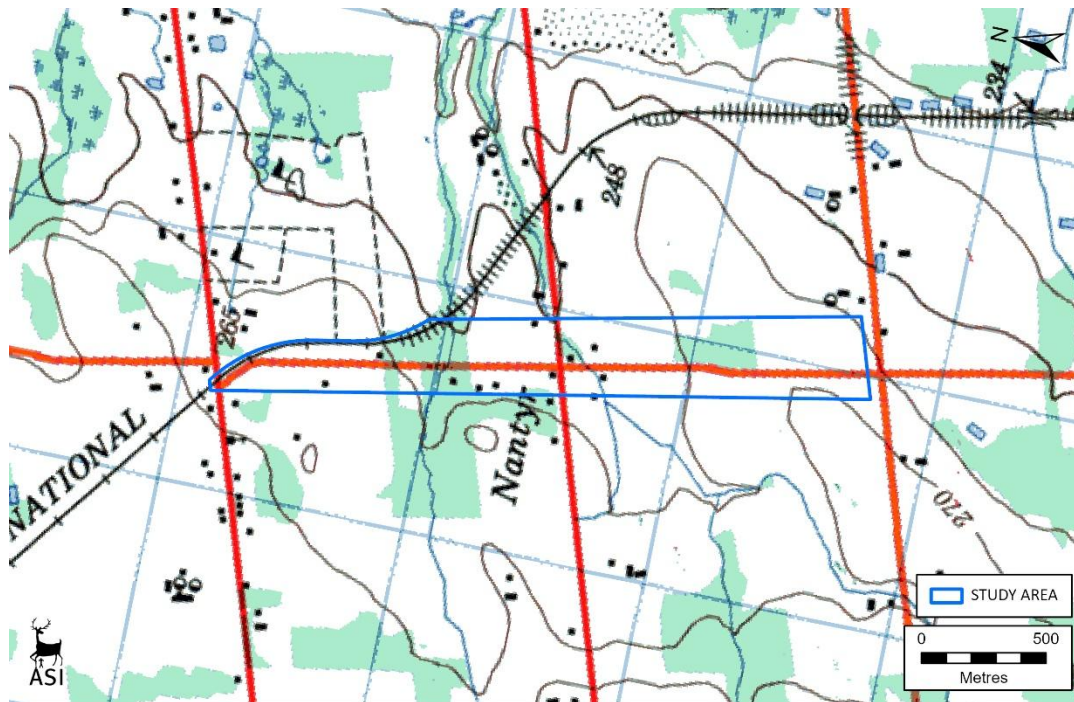
Figure 6: The study area overlaid on the 1986 topographic map of Barrie (Base Map: (Department of Energy, Mines and Resources, 1986)).

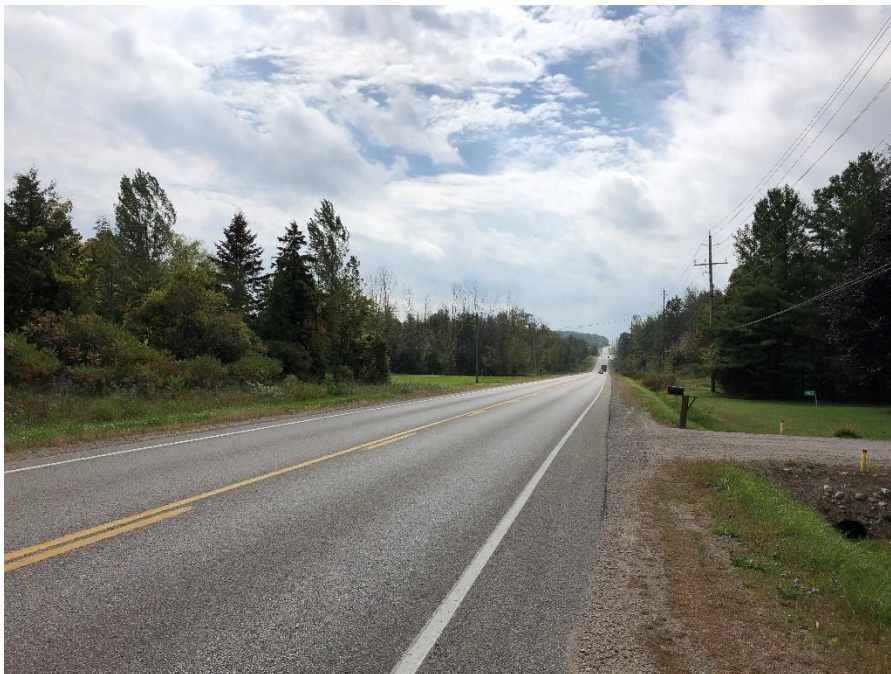
Plate 3: 20<sup>th</sup> Sideroad, looking south showing representative rural residential and agricultural conditions.

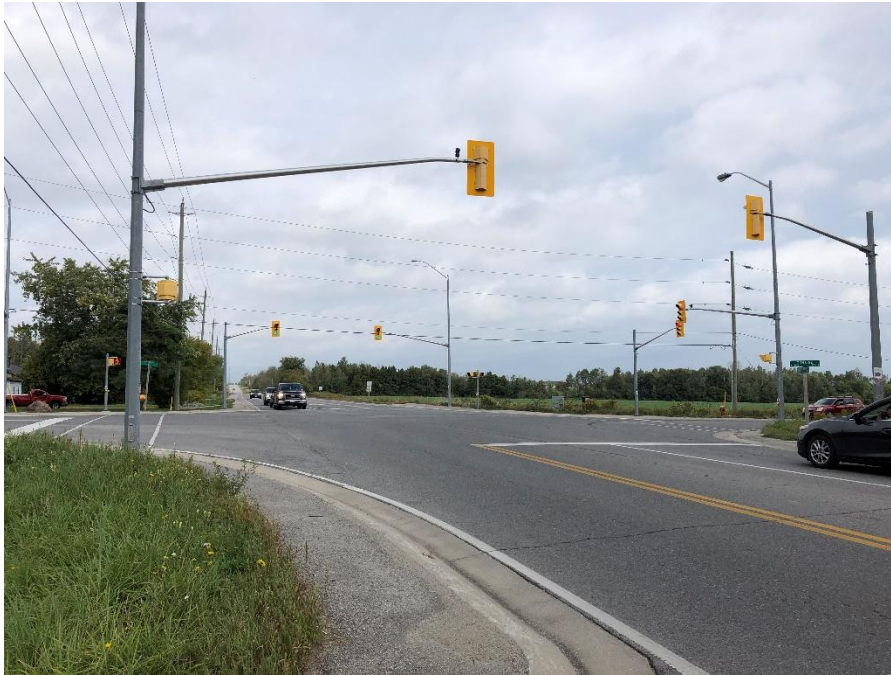
Plate 4: 20<sup>th</sup> Sideroad, looking north to the intersection with 7<sup>th</sup> Line in the central portion of the study area.
